ROCKY FLATS CLOSURE PROJECT

BUILDING

771

"THE MOST DANGEROUS
BUILDING IN AMERICA"
READY FOR DEMOLITION

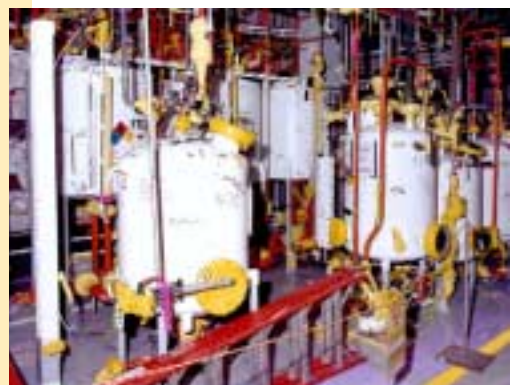
In 1995, tanks containing plutonium solutions.

A report issued in 1994 by the Department of Energy ranked Building 771 as its most vulnerable plutonium facility. The most urgent risks at Building 771 resulted from large quantities of plutonium solutions stored in aging tanks, process piping and four-liter bottles inside gloveboxes. Plutonium solutions are less stable than other forms of plutonium. Numerous leaks in the building's tanks and piping systems were also identified in the DOE's findings.

Initial cleanup work at Building 771 focused on the highest risks. Workers began stabilizing plutonium solutions stored in bottles in 1993. Workers began draining tanks in 1994 and by 1998 started draining and removing process piping. To ensure that the piping system posed no further hazard and to work with the safest conditions, pipes were removed immediately after draining. Because of the dangers of worker contamination from plutonium solutions and nuclear criticality safety concerns, the work was slow and carefully controlled. Solutions were drained using strict nuclear safety procedural controls.

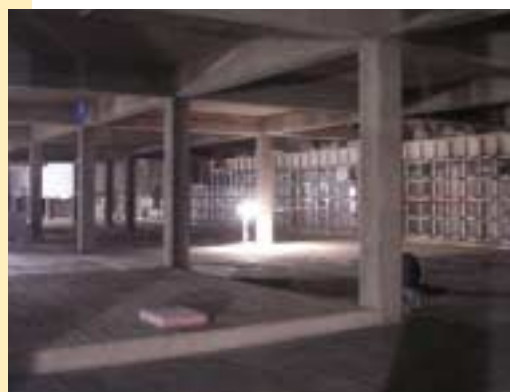
Today, the building has been completely stripped of all equipment.

While workers mitigated the risks posed by stored plutonium, others began removing highly-contaminated equipment from the facility. This work included the removal of 240 stainless steel gloveboxes, more than 250 tanks, more than 11 miles of process piping and all of the equipment used in plutonium recovery operations.

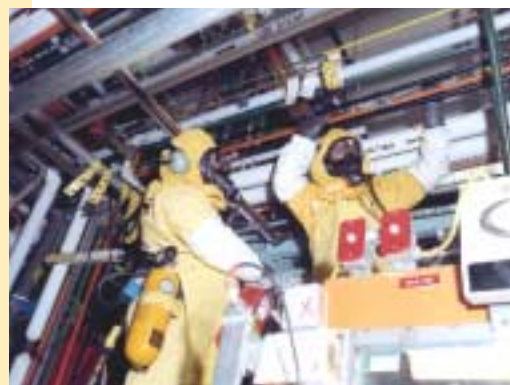
Workers drained and removed more than 11 miles of piping containing plutonium solutions.

The last radioactive liquids were drained from process piping in 2001 and, by 2003, the facility was cleaned to the point that a nuclear criticality accident was improbable.

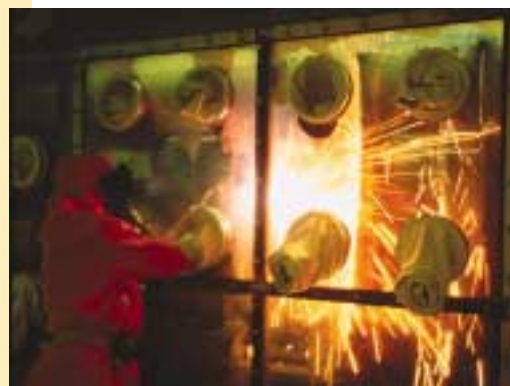
Using plasma-arc torches to cut up stainless steel gloveboxes significantly improved safety.

- **Plasma-arc torches:** Large, highly-contaminated stainless steel gloveboxes and other large pieces of equipment need to be cut up to fit in standard waste shipping containers. To do this at Rocky Flats, workers use mechanical Sawzalls and stainless steel “nibblers” to cut equipment within the confines of a tent structure erected to contain the spread of contamination. A notable feature of glovebox cutting at Building 771 was the development of plasma-arc cutting of gloveboxes which reduced exposure to workers and, because of the light weight compared to mechanical cutting equipment, eliminated industrial and ergonomic hazards.

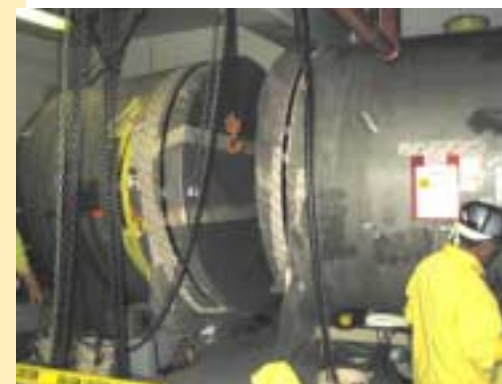
Large tanks also had to be cut into pieces to fit in radioactive waste shipping containers.

Glovebox, tank and equipment dismantlement: Removing hundreds of highly-contaminated gloveboxes and tanks, many the size of a railcar, often requiring size reduction and significant decontamination efforts.

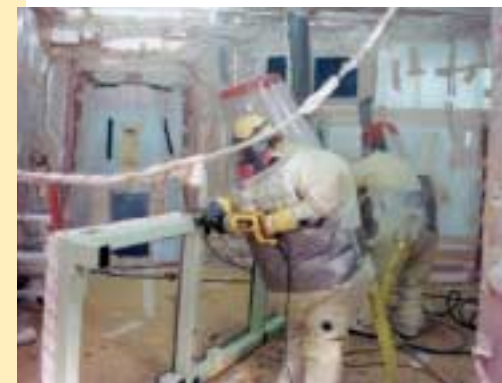
Workers were required to wear cumbersome protective clothing while dismantling equipment.

Cutting the contaminated gloveboxes, tanks and other equipment into a size that would fit into waste containers was difficult and rife with hazards. Workers wearing cumbersome protective clothing cut up glovebox sections that contained up to three-quarter-inch-thick stainless steel.

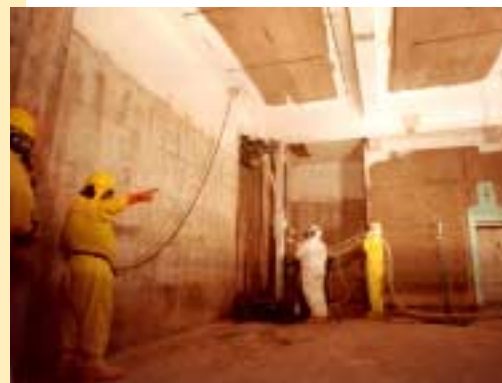
Workers use ultra high pressure water jets to decontaminate the structure.

Structural decontamination: Removing residual contamination from the walls, floor and ceiling of the structure using ultra high-pressure water spray that blasts away layers of concrete.

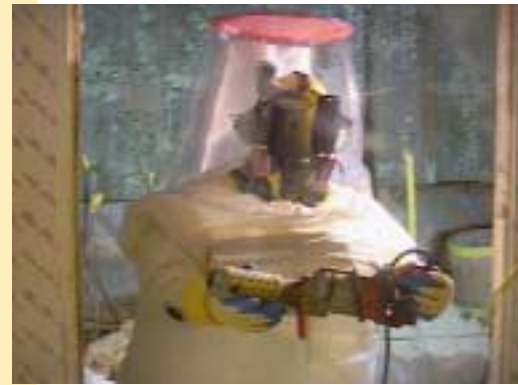
A worker removes an old, abandoned jackhammer from the "Infinity Room."

Workers also faced hazards posed by some of the most contaminated areas at Rocky Flats. Room 141, the building's infamous "infinity room" – so named because radiation levels inside pegged radiation detection equipment 25 years ago and prompted operators to seal and abandon the room – posed significant challenges. Initial readings in the room in 2002 revealed airborne plutonium contamination levels 2,000 times higher than maximum limit for safe entry. An innovative approach to control airborne levels using a glycerin-based fog, remotely pumped into the room, caused contamination to adhere to surfaces. Airborne contamination was reduced below limits, allowing workers to enter in supplied air breathing suits to remove and package equipment stored in the room and spray fixative to further control contamination.

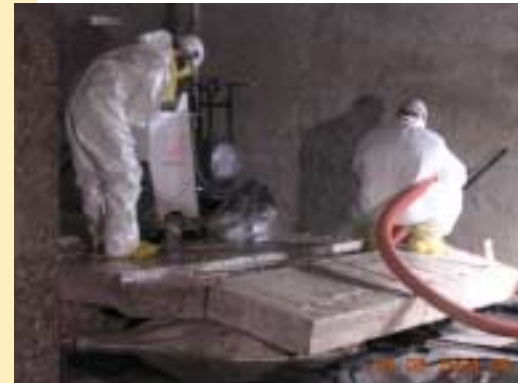
The walls, floor and ceiling of the "Infinity Room" were cut into blocks for shipment to a radioactive waste disposal site.

The final and most labor-intensive job involved removing the room itself. Workers developed an innovative approach using diamond wire saws to cut the 3-foot-thick ceiling, floor and walls and

then used concrete saws to cut the slabs into blocks suitable for packaging. The entire room was cut up and shipped to the Waste Isolation Pilot Plant in New Mexico, a transuranic waste receiving facility.
